The condition of thermally modified cypress and Douglas fir flat panels after one year's field exposure

Date: May 2023

Publication No: SWP-T171

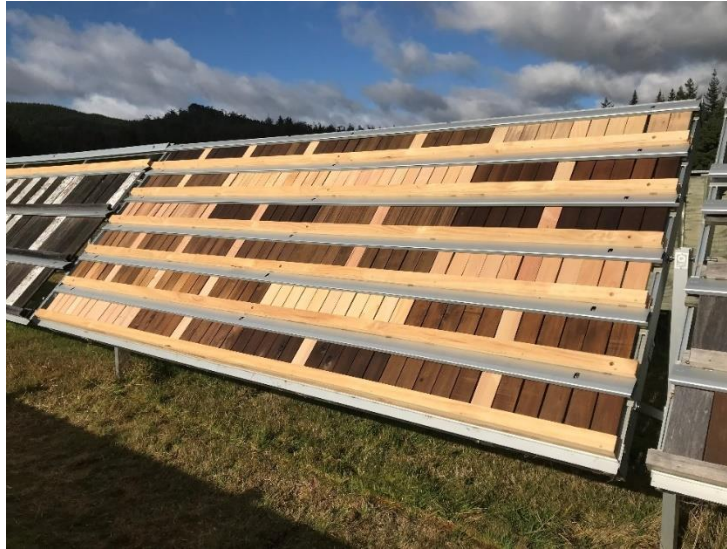
The flat panel trial was installed on a North facing frame at approximately 45° (Figure 1). Some of the flat panels were stained with a dark black stain prior to exposure, the other samples were uncoated. The bottom edge of each flat panel sits in a wooden slot made from untreated radiata pine. The top edge of the panel rests on a 20 x 45 mm strip of H3.2 (CCA) treated radiata pine.

Figure 1: General view of flat panel trial at the time of installation (July 2021).

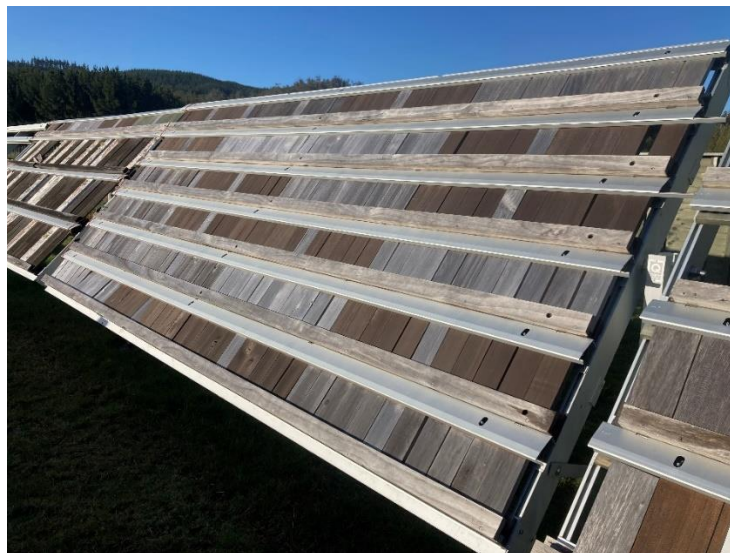
The exposed face of the unstained samples had turned a light silver colour after one years exposure (Figure 2). Some minor mould spots were observed on the Accoya samples. Black mould was observed on the back of many of the untreated unstained radiata pine samples.

Figure 2: General view of flat panel trial after one year's exposure (July 2022).
